## Preliminary Arborist Report

### West Oakland BART Station Oakland, CA

**May 2026**

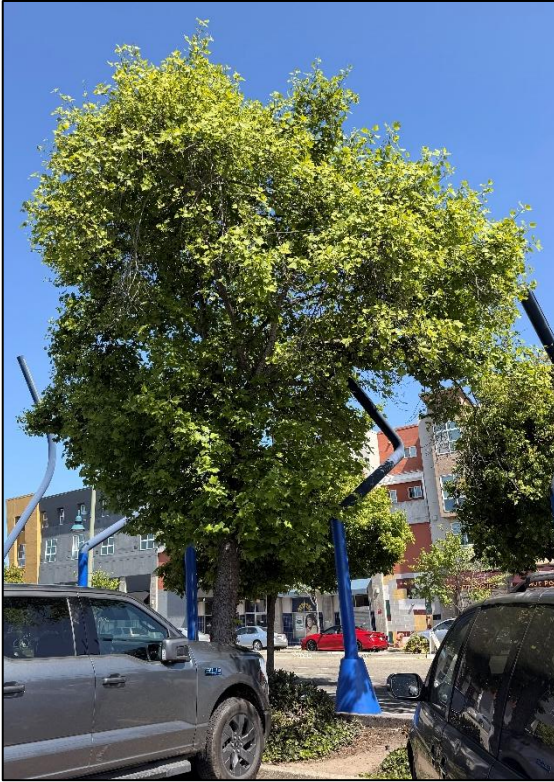
Twenty-two (22) tulip trees were assessed, representing about a third of the trees inventoried. Eighteen (18) trees were in fair condition, tree #44 was in good condition and trees #34, 35, and 59 were in poor condition. The tulip trees in fair condition were characterized by having narrow crowns and some twig and branch dieback (Photo 1, next page). Tulip trees in poor condition had extensive wounding along their trunks (Photo 2, next page). The tulip trees ranged in diameter from 7 to 14 inches. Tree #47 had three trunks with diameters of 6, 7, and 8 inches.

**Photo 1.** Tulip tree #19 was in fair condition. Tree #19 was growing in an open planter with compacted soils and ivy.

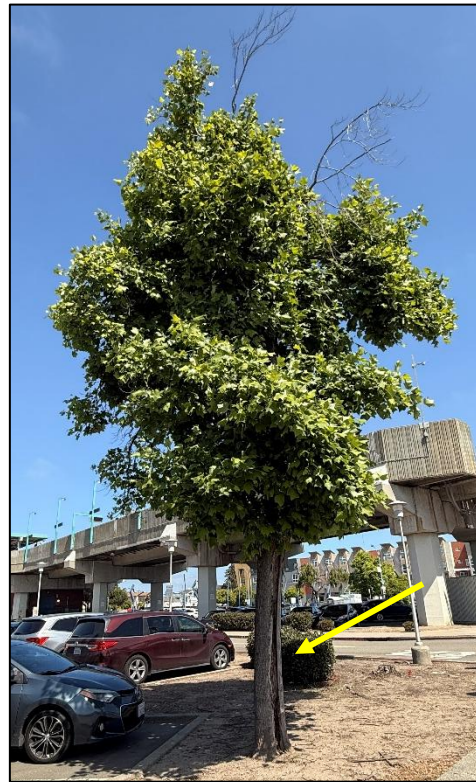
**Photo 2.** Tree #34 was in poor condition with branch dieback, and a trunk wound that span from the base to high in the crown.

- **Tree health**  
Healthy, vigorous trees are better able to tolerate impacts such as root injury, demolition of existing structures, changes in soil grade and moisture, and soil compaction than are non-vigorous trees. For example, trees #34 and 35 were in poor health with trunk wounds spanning much of the length of the trunk.
- **Structural integrity**  
Trees with significant amounts of wood decay and other structural defects that cannot be corrected are likely to fail. Such trees should not be preserved in areas where damage to people or property is likely. For example, mayten #30 had poor structure and would not be a good candidate for preservation.

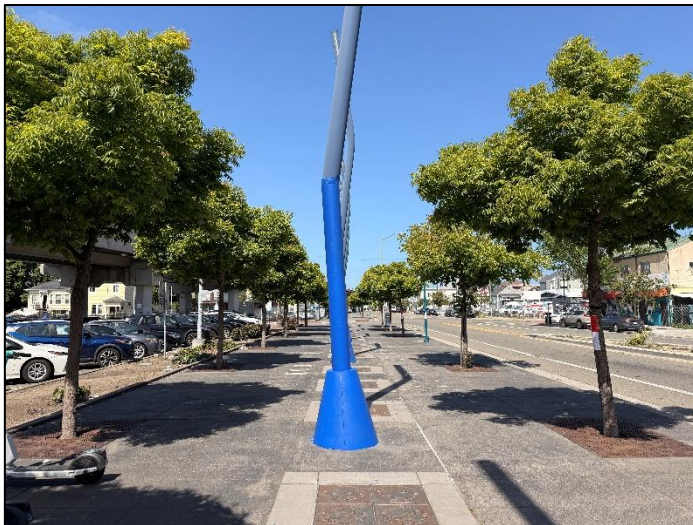
The 20 Chinese pistache were in good condition. Size variance was minor with diameters ranging from 4 to 7 inches. The Chinese pistache were growing in a double allée on the southern side of 7<sup>th</sup> St. and were in tree wells with grates (Photo 3). The trunks of trees #2, 11, 12, and 23 contacted with the tree grate.

**Photo 3.** The good condition Chinese pistache trees created a double alley of trees that lined the parking lot on the south side of 7<sup>th</sup> St.

Trees where preservation may be possible with design changes include: Twenty (20) Chinese pistache, three red horsechestnuts, the four red maples, marina madrone #67 and Italian stone pines #16 and 17. Preservation of American elm #64 is not recommended because the species has historically been plagued with structural issues.

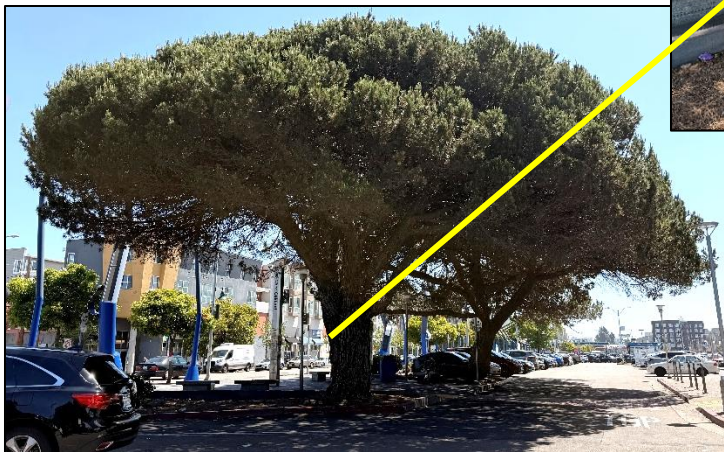
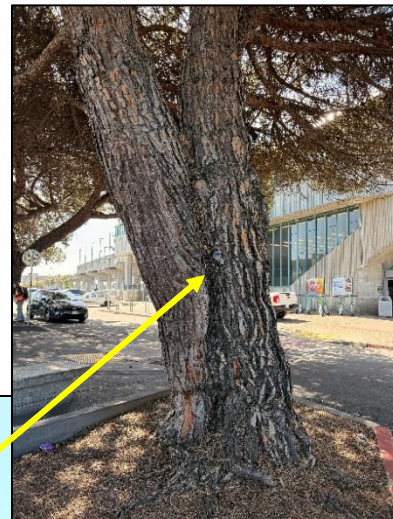
Italian stone pine #16 and 17 were the largest trees assessed with diameters of 40 and 47 inches. Both trees were in good condition and had codominant trunks. Tree #16 had a seam in the attachment from the attachment point to the base and tree #17 was swelling at the main attachment (Photo 4, and popout). The trees were growing in large parking islands with displaced curbs and gutters.

**Photo 4.** The good condition Italian stone pines both trees had codominant stems with a seam in the attachment.

It may be possible to preserve 29 trees along 7<sup>th</sup> Street. Revised plans would need to be reviewed by the consulting arborist to determine impacts to trees and provide recommendations for protection during the construction process. Revisions would need to leave existing features relatively similar or focus on removal of concrete and hardscape features. A Tree Protection Zone of at least 20-feet in all directions would be required for preservation of the Italian stone pine #16 and 17. No work, other than removal of concrete, would be allowed in this area.
